**Flood Control Project Maintenance
Levee Inspections**

Spring 2014 Levee Inspection Results

Merced Streams Group

| Waterway | | | Bank | Unit Miles |
|--|---|---|---|---|
| Unit No. 01 Black Rascal Diversion | | | Right | 1.64 |

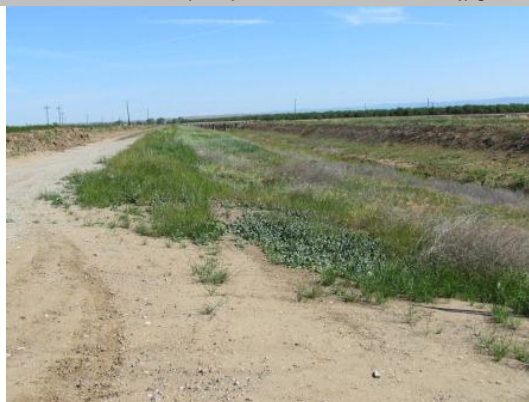
Photo 1 of 1 : phillips_s_20140512_05854.jpg

Black Rascal Creek looking upstream from levee mile 0.01. Photo taken 4-23-2014.

| Control annual grass and weeds on the levee slopes and easements. | | | | | |

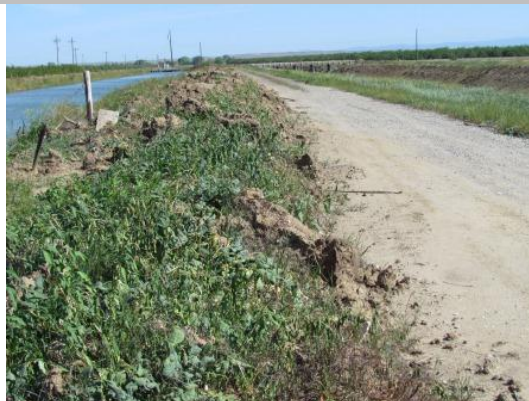
Photo 1 of 1 : phillips_s_20140512_05853.jpg

| Material Inspector Comments: District has cleaned out the main canal adjacent to the landside toe and has placed the dredged material along the landward bank to dry out. | | | | | |

Dredged material placed on the landward shoulder. Photo taken 4-23-2014.

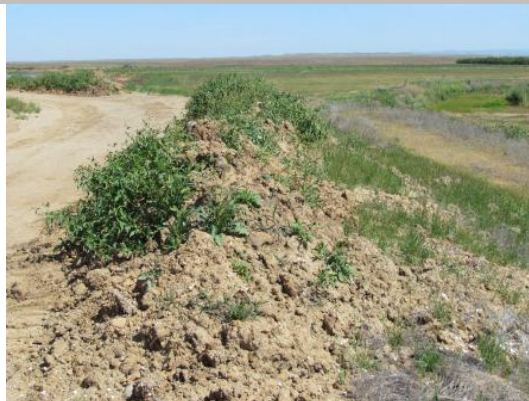
Photo 1 of 1 : phillips_s_20140512_05856.jpg

Dredged material placed on waterward shoulder from channel. Photo taken 4-23,-2014.

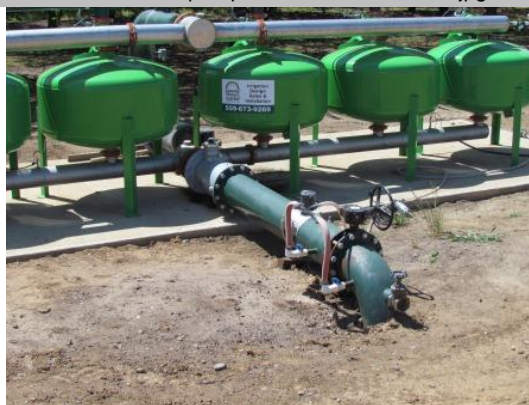
Photo 2 of 2 : phillips_s_20140512_05857.jpg

Black Rascal Creek There is no CVFPB Permit on file for this installation. Photo taken 4-23,-21014

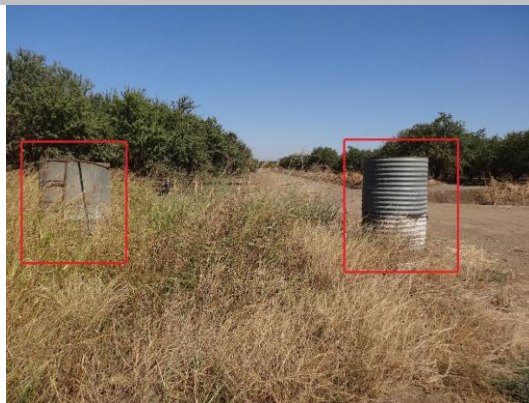
Photo 1 of 1 : UCIP_2495.jpg

WS view: concrete standpipe (left) and CMP standpipe (right).

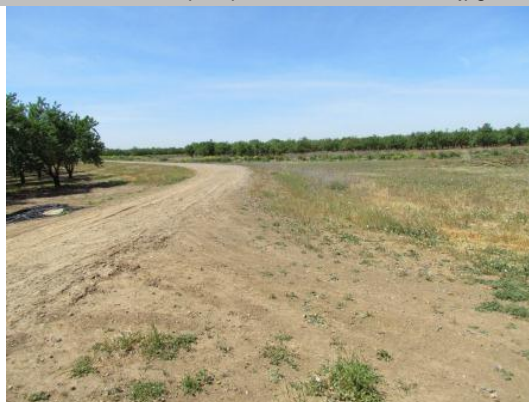
Photo 1 of 1 : phillips_s_20140512_05860.jpg

Looking downstream from levee mile 0.03. Photo taken 4-23-2014.

| Control annual grass and weeds on the levee slopes and easements. | | | | | |

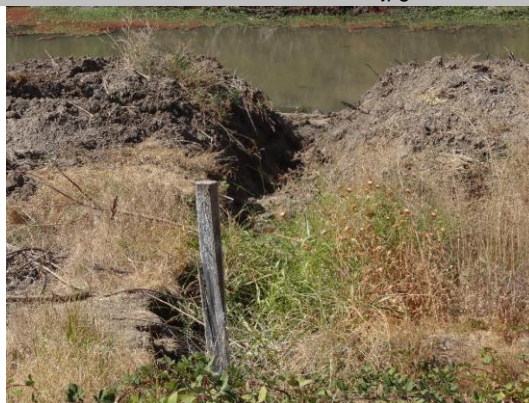
Photo 1 of 1 : UCIP_2378.jpg

WS view: cobble spillway and channel on waterside.

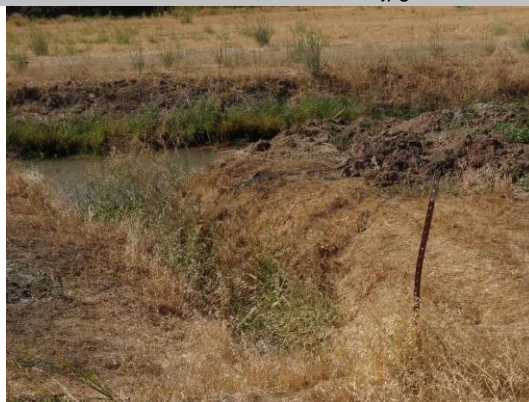
Photo 1 of 1 : UCIP_2392.jpg

WS view: cobble spillway and channel on waterside.

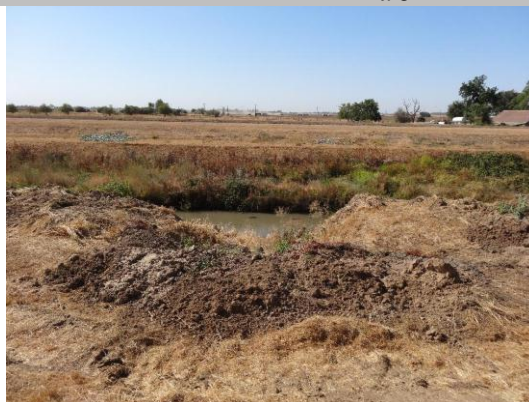
Photo 1 of 1 : UCIP_2406.jpg

WS view: concrete headwall and CM pipe burried under debris and mud.

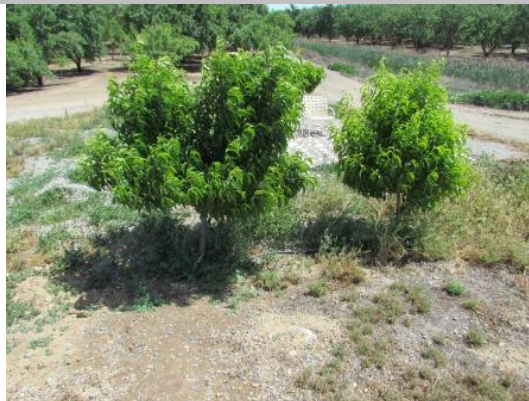
Photo 1 of 2 : phillips_s_20140512_05861.jpg

| Inspector Comments: Three fruit trees with irrigation system, stock pie of material (2) piles on the land side toe and rock pad placed n land side toe. | | | | | |

Unauthorized fruit trees planted on the landward toe. Photo taken 4-23-2014.

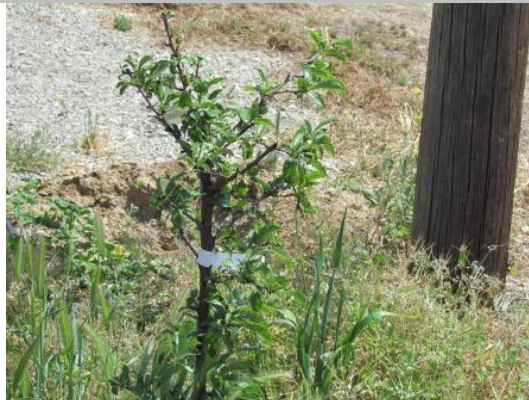
Photo 2 of 2 : phillips_s_20140512_05862.jpg

Unauthorized fruit tree placed on the landward toe. Photo taken 4-23-2014.

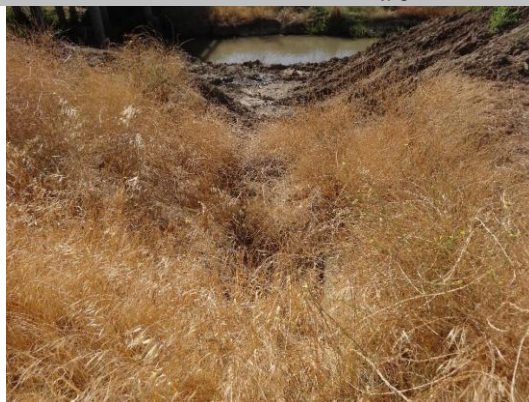
Photo 1 of 1 : UCIP_2394.jpg

WS view: overview of outlet area and channel. Debris and vegetations on spillway.

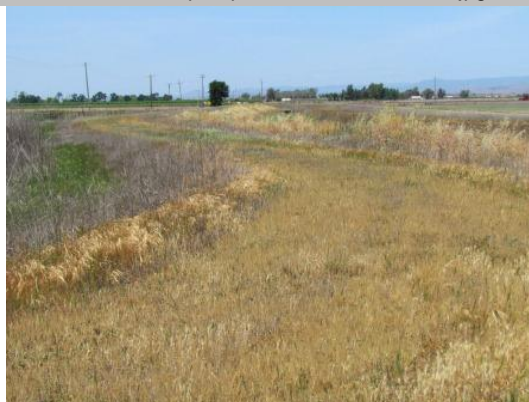
Photo 1 of 1 : phillips_s_20140509_05850.jpg

Looking upstream at overgrown crown roadway. Photo taken 4-23-2014.

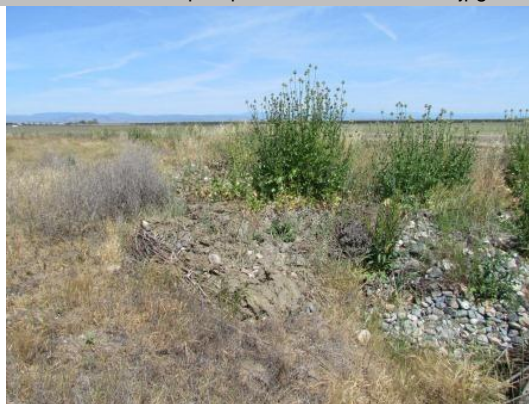
Photo 1 of 1 : phillips_s_20140509_05851.jpg

Unsatisfactory wild growth on waterside of levee section. Photo taken 4-23-2014.

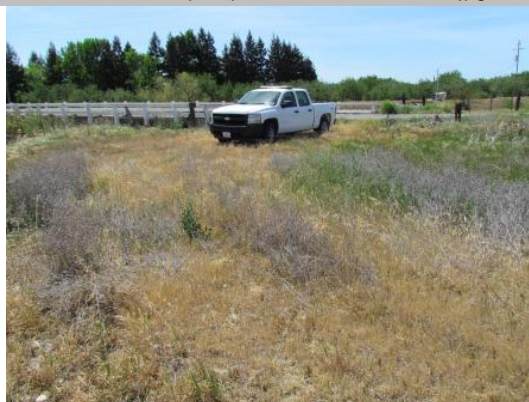
Photo 1 of 1 : phillips_s_20140509_05852.jpg

Looking downstream at overgrown waterside and crown roadway. Photo taken 4-23-2014.

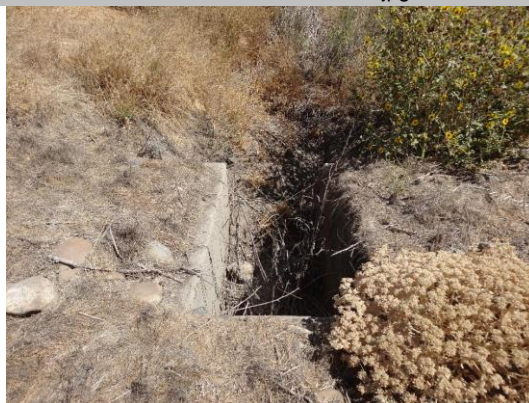
Photo 1 of 1 : UCIP_2409.jpg

WS view: U typed concrete headwall, cobble spillway, and channel on waterside.

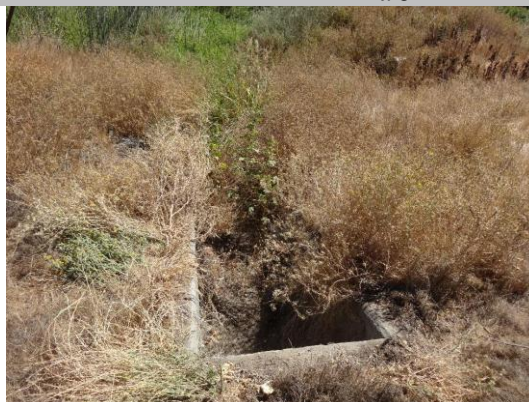
Photo 1 of 1 : UCIP_2450.jpg

WS view: cobble spillway and channel on waterside. Dense vegetation on levee slope.

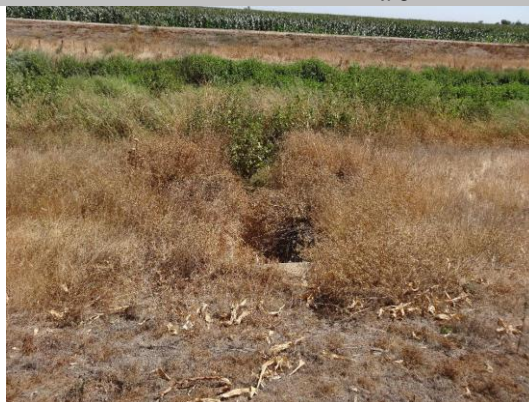
Photo 1 of 1 : UCIP_2454.jpg

WS view: overview of spillway/outlet area on waterside.

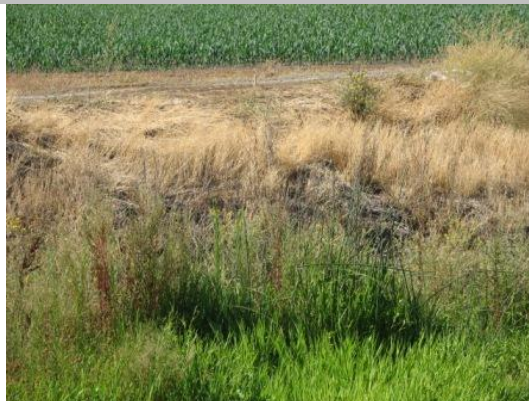
Photo 1 of 3 : phillips_s_20140414_717.jpg

Inspector Comments: 07/31/2012: Site was visited on 07/26/2012. No significant changes observed. Dense vegetation presents at the site. 08/16/2011: No visible change. 100 percent vegetation coverage with star thistles. Minor cracking visible on the waterside slope. 11/30/2010: Site was not inspected this year due to time constraint. There have been no reports from the district that this site was corrected. Continue to monitor during flood events. 2009: Site is recommended as local maintenance issue, per CLRO CES Evaluation 2008 Report; it was previously rated "U". 8/26/2008: Terracetting erosion; frequent livestock traversing the slopes has caused deformation of the waterside levee slope. 9/11/2007: GPS extended from opposite bank using Google Earth. [2012 Site ID:NA0013U03RM1]

A close look at the site, which is covered by thick vegetation

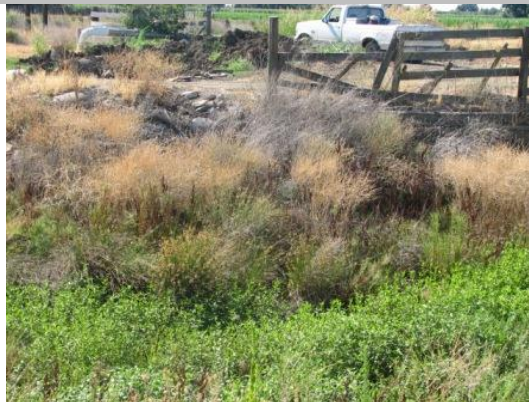
Photo 2 of 3 : phillips_s_20140414_718.jpg

Site covered with dense vegetation.

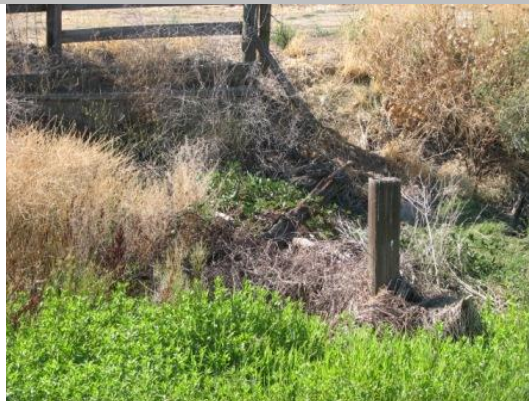
Photo 3 of 3 : phillips_s_20140414_719.jpg

Wooden posts and fence on site

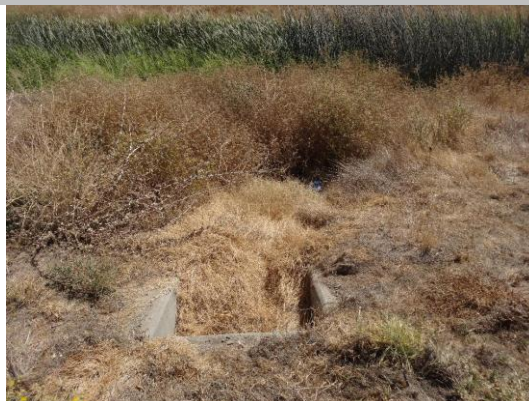
Photo 1 of 1 : UCIP_2459.jpg

WS view: cobble spillway and channel on waterside.

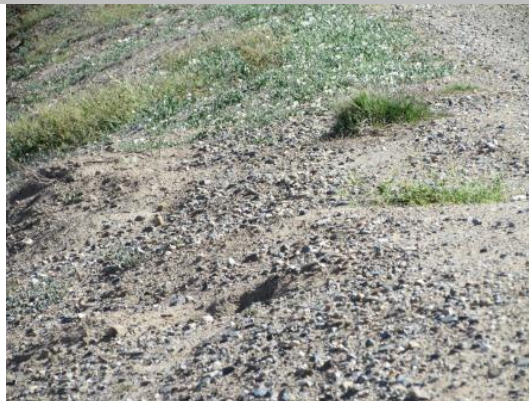
Photo 1 of 1 : phillips_s_20140512_05863.jpg

Levee slope taken over by rodents, levee mile 1.11-1.24. Photo taken 4-23,-2014.

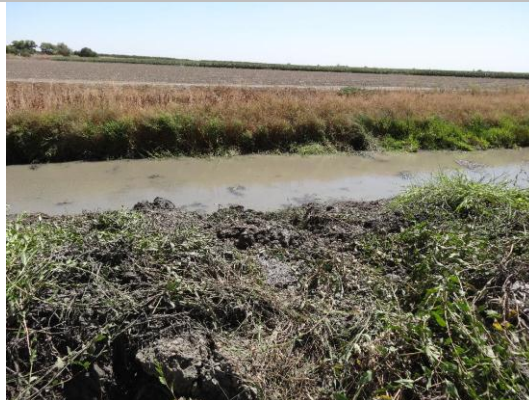
Photo 1 of 1 : UCIP_2433.jpg

WS view: U typed concrete headwall, CM pipe, and flap gate buried under mud/debris.

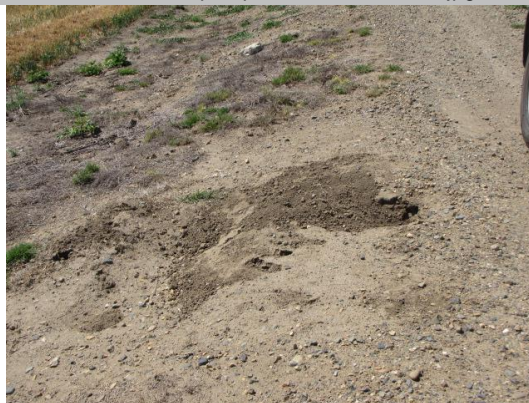
Photo 1 of 1 : phillips_s_20140414_722.jpg

Landside slope taken over by rodents. Photo taken 4-18-2013.

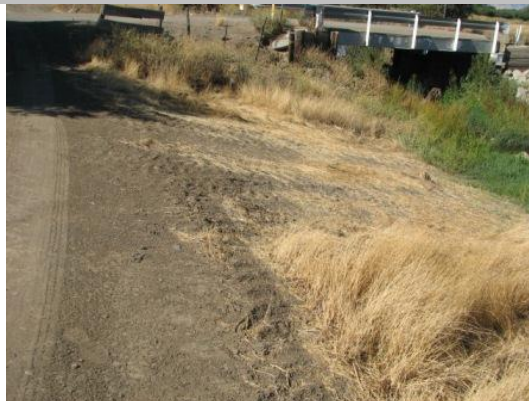
Photo 1 of 2 : phillips_s_20140414_720.jpg

| Inspector Comments: 07/31/2012: Site was visited on 07/24/2012. No significant changes observed. Dried grass covered the site. Dense vegetation. | | | | | |
| 08/16/2011: No visible change. 100 percent vegetation coverage with star thistles. Minor cracking visible on the waterside slope. Burrow holes visible. | | | | | |
| 2009: Bank erosion scour that is immediately downstream of Mission Avenue bridge; noticeable terracetting damage from livestock traversing the slope; site is recommended as local maintenance issue, per CLRO Evaluation 2008 Report; site was previously rated "M". | | | | | |
| 8/26/2008: Terracetting damage from livestock; there is now a pocket erosion developing on the levee toe; site is 100 feet downstream of Mission Avenue bridge. [2012 Site ID:NA0013U03RM1.25] | | | | | |

The site is covered with dense thistles.

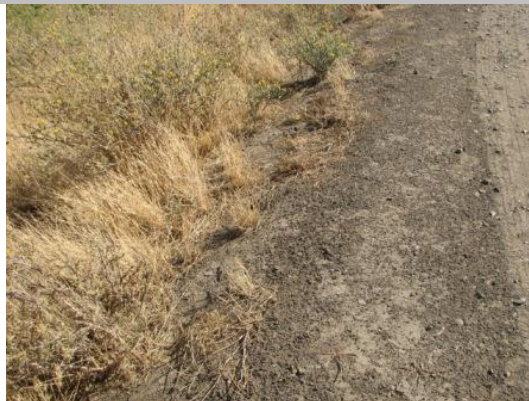
Photo 2 of 2 : phillips_s_20140414_721.jpg

No significant change visible from the levee top

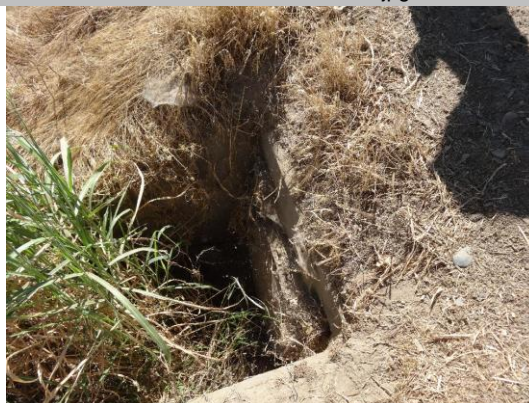
Photo 1 of 1 : UCIP_2436.jpg

WS view: U typed concrete headwall, CM pipe, and flap gate. Vegetation needs to be cleared.

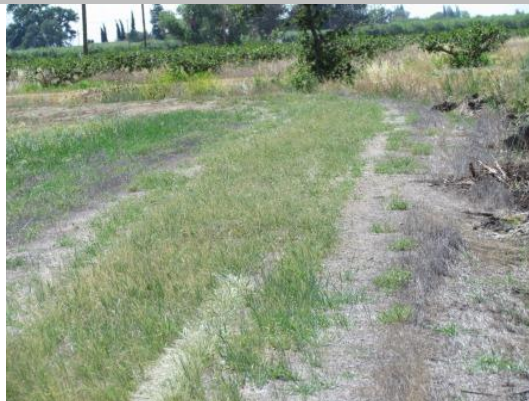
Photo 1 of 1 : phillips_s_20140509_05849.jpg

Owens Creek Unit 4 looking downstream from levee mile 0.01. Photo taken 4-23-2014.

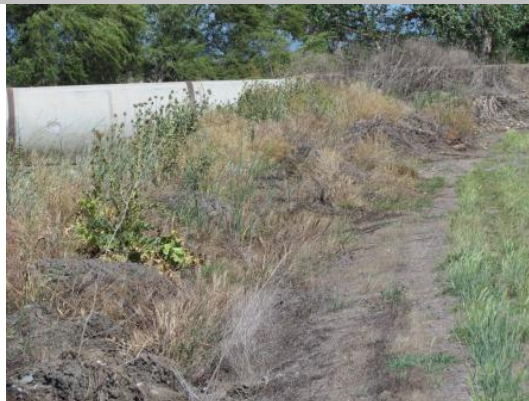
Photo 1 of 2 : phillips_s_20140512_05864.jpg

Looking back upstream from levee mile 0.06 waterside the canal has been dredged and the material placed on waterward bank. Photo taken 4-23-2014.

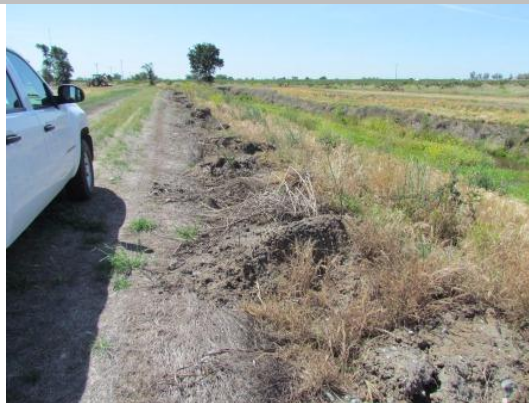
Photo 2 of 2 : phillips_s_20140512_05865.jpg

Looking downstream from levee mile 0.06 to 0.30 at dredging on the waterward bank. Photo taken 4-23-2014.

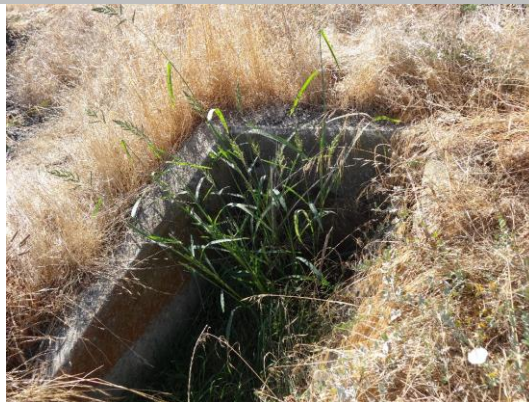
Photo 1 of 1 : UCIP_2493.jpg

WS view: concrete spillway and channel on waterside. Dense vegetation on levee slope and spillway.

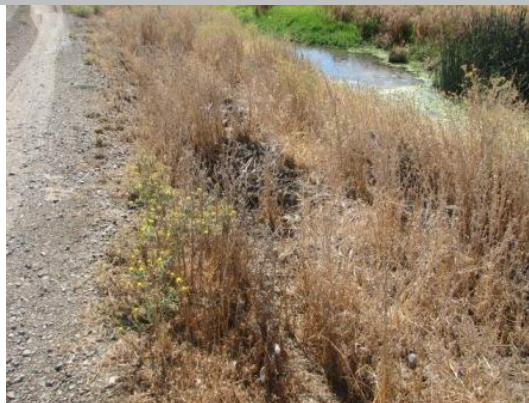
Photo 1 of 2 : phillips_s_20140414_731.jpg

| Inspector Comments: 07/31/2012: No significant changes observed 08/16/2011: No significant change was visible. Minor cracking on the waterside levee slope was spotted. 100 percent vegetation coverage with star thistles. 11/30/2010: Site was not inspected this year due to time constraints. There have been no reports from the district that the site has been corrected. 2009: Site recommended as local maintenance issue, per CLRO CES Evaluation 2008 Report; previously rated "U". 9/10/2007: GPS extended from opposite bank using Google Earth; signs of vehicular damage on levee. [2012 Site ID:NA0013U04RM0.21] | | | | | |

The site is covered with dense star thistles. No significant changes visible.

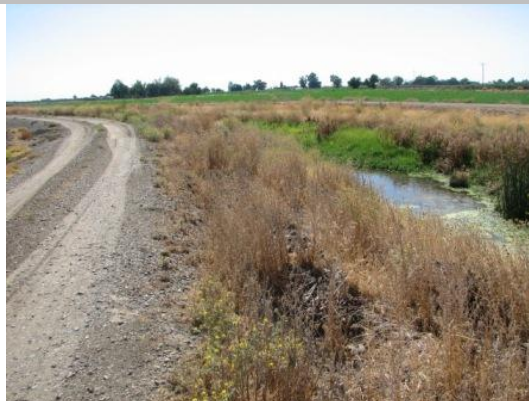
Photo 2 of 2 : phillips_s_20140414_732.jpg

The site is covered with dense star thistles.

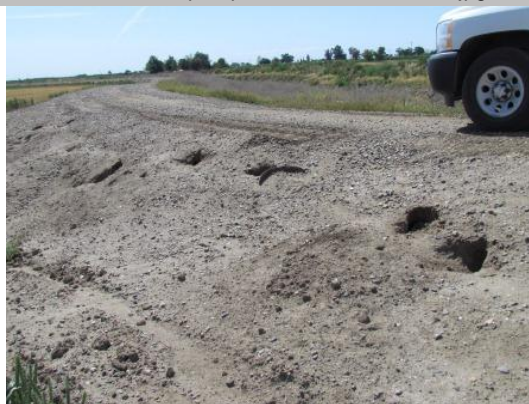
Photo 1 of 1 : phillips_s_20140509_05848.jpg

Unsatisfactory rodent activity on landside levee slope. Photo taken 4-23-2014.

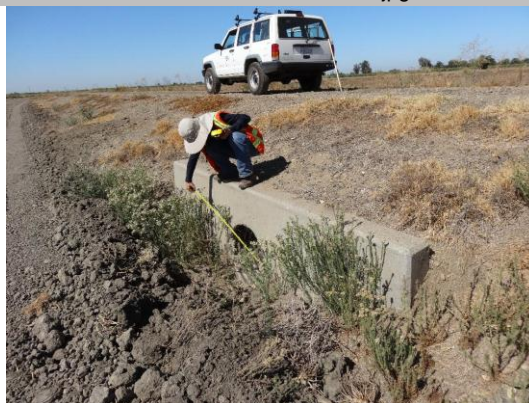
Photo 1 of 1 : UCIP_2465.jpg

LS view: concrete headwall and CM pipe. Inlet needs clearing.

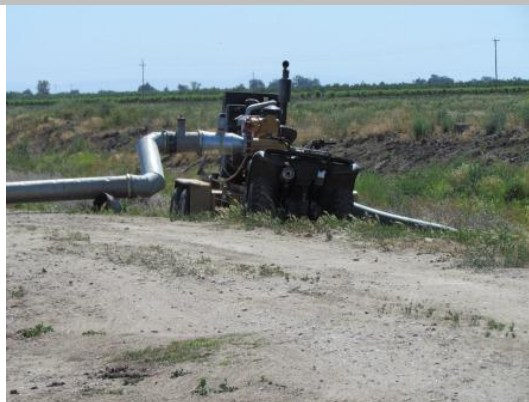
Photo 1 of 3 : phillips_s_20140509_05845.jpg

New Unauthorized pipe blocking access to levee crown roadway. Photo taken 4-23-2014. Waterside view.

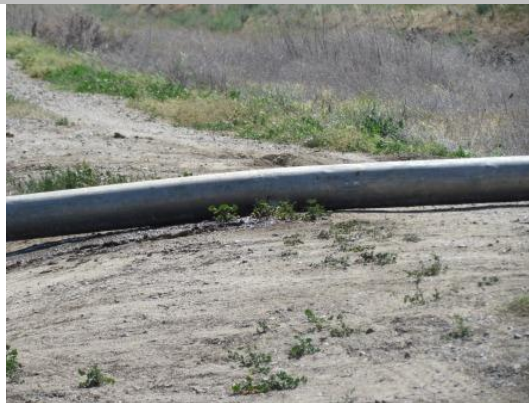
Photo 2 of 3 : phillips_s_20140509_05846.jpg

Another view of the pipe blocking access to levee crown roadway.
Photo taken 4-23-2014. Crossing crown

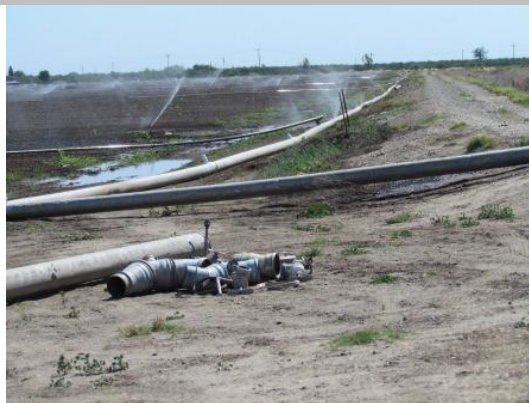
Photo 3 of 3 : phillips_s_20140509_05847.jpg

Landside view of unauthorized pipe crossing levee crown. Photo taken 4-23-2014.

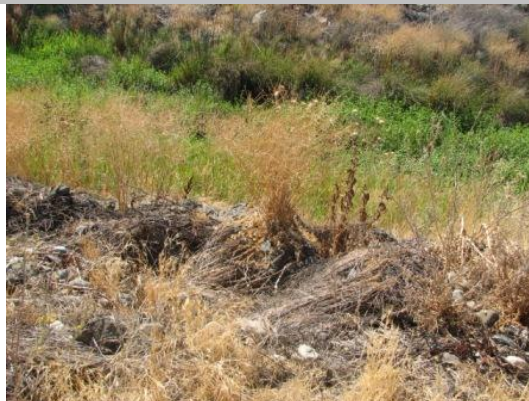
Photo 1 of 2 : phillips_s_20140414_733.jpg

| Inspector Comments: 07/24/2012: No significant changes observed. | | | | | |

Direct look at the site

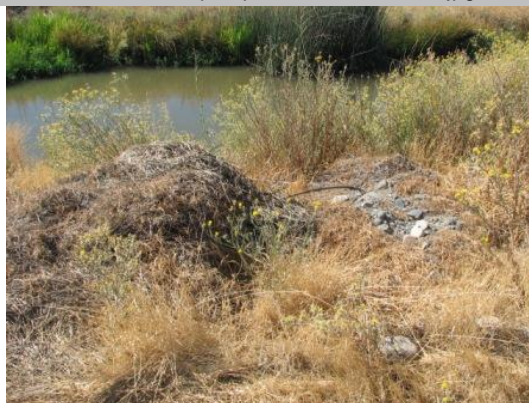
Photo 2 of 2 : phillips_s_20140414_734.jpg

The site is covered with thick vegetation

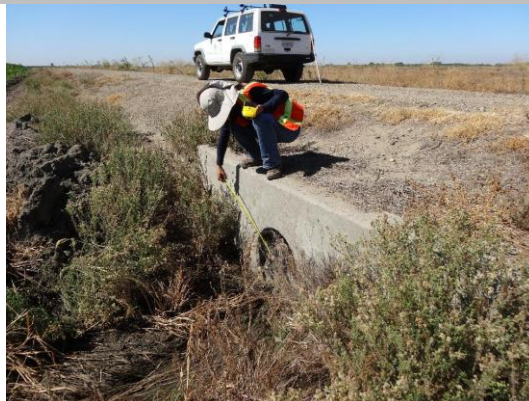
Photo 1 of 1 : UCIP_2466.jpg

LS view: concrete headwall and CM pipe.

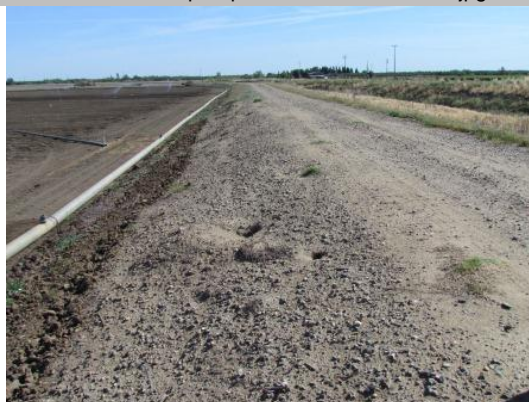
Photo 1 of 1 : phillips_s_20140512_05866.jpg

Rodents are active here, these holes are fresh with tracks. Photo taken 4-23-2014.

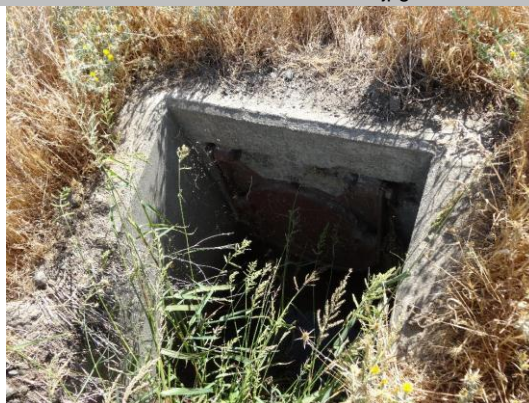
Photo 1 of 1 : UCIP_2472.jpg

WS view: U typed concrete headwall, CM pipe, and flap gate. Vegetation needs to be cleared.

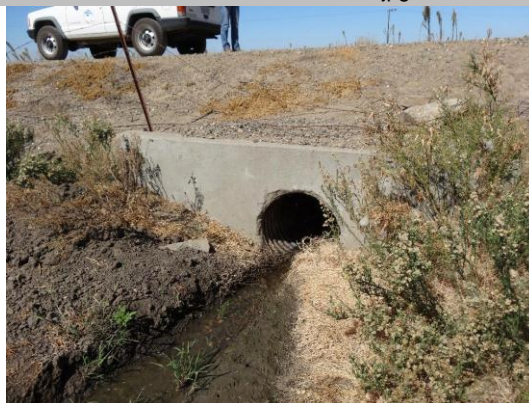
Photo 1 of 1 : UCIP_2479.jpg

LS view: concrete headwall and CM pipe. Drain pipe was working during field survey.

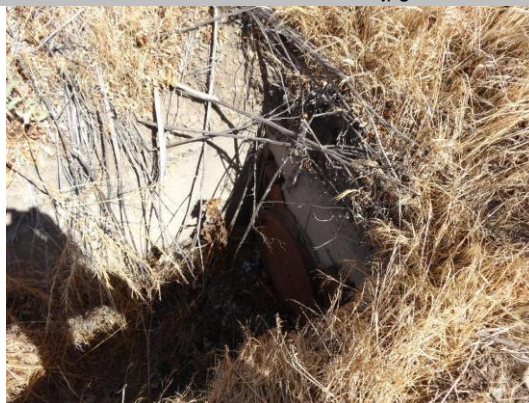
Photo 1 of 1 : UCIP_2487.jpg

WS view: concrete spillway and channel on waterside. Dense vegetation on levee slope and spillway.

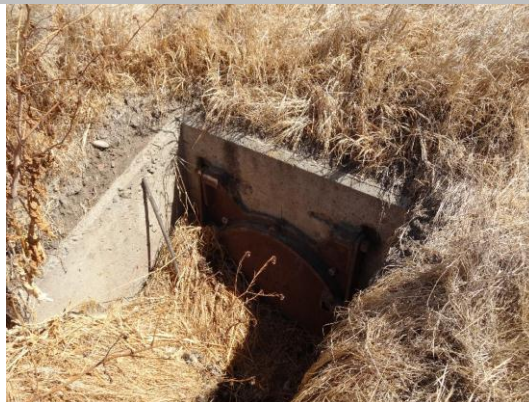
Photo 1 of 1 : UCIP_2490.jpg

WS view: U typed concrete headwall, CM pipe, and flap gate. Dirt and vegetations need to be removed and cleared.
